Crystal Lake Conservancy Annual Forum

What we hope to accomplish this Evening Regarding Crystal Lake

Crystal Lake Limnology

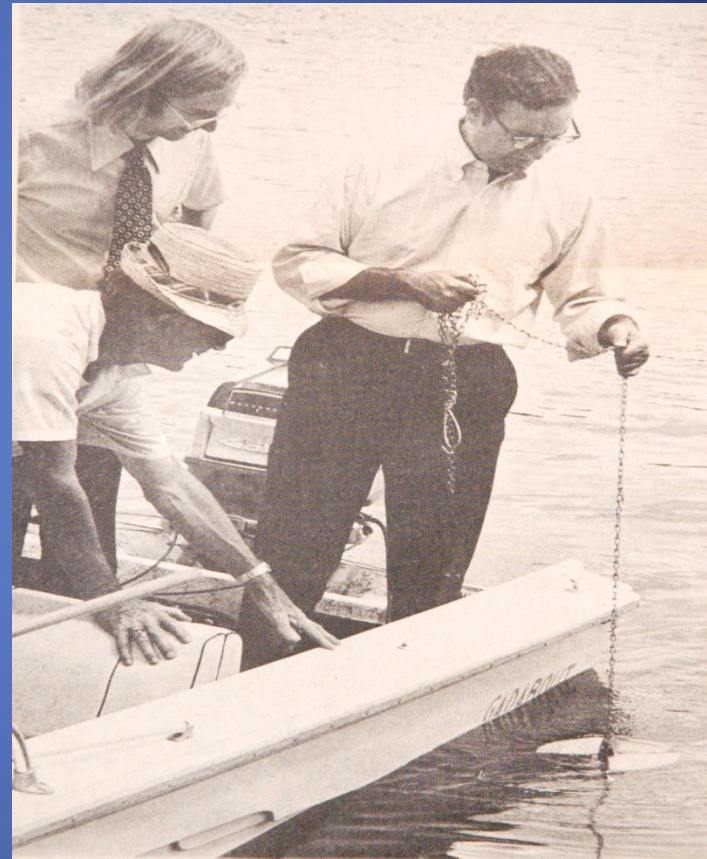
Testing murky waters

Democratic gubernatorial candidate George Mitchell takes a try at lowering a disc device into Annabessacook Lake. The disc is used to measure relative clarity of the water. Shown looking on are Thomas Gordon, executive director of the Cobblesee Watershed District, and George Jacobs of the Annabessacook Lake Association.

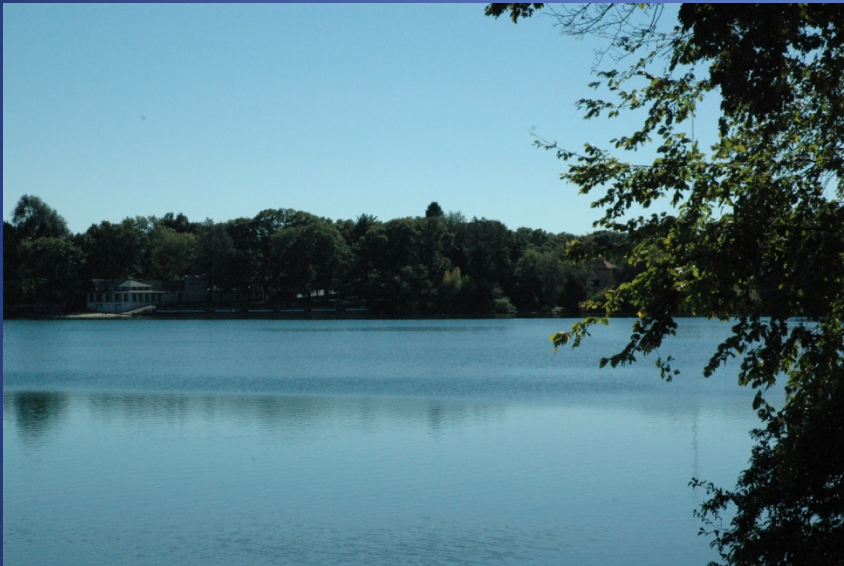
Crystal Lake Statistics

- 33 acres (13 ha)
- Classified as a Great Pond
- Drains into the Charles River
- Shoreline is about one mile
- Length is 1,200 ft (N/S)
- Width is 1,000 ft (E/W)
- Greatest Depth is about 31 ft

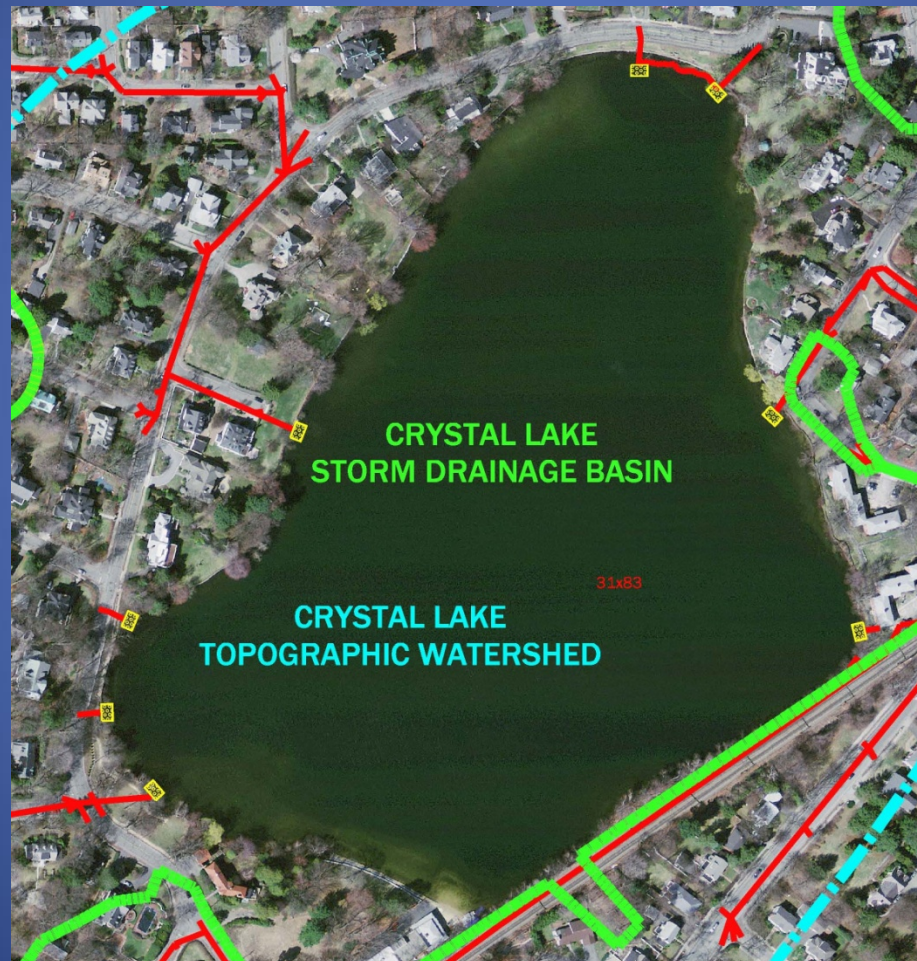
Storm Water Discharge Point into Crystal Lake
